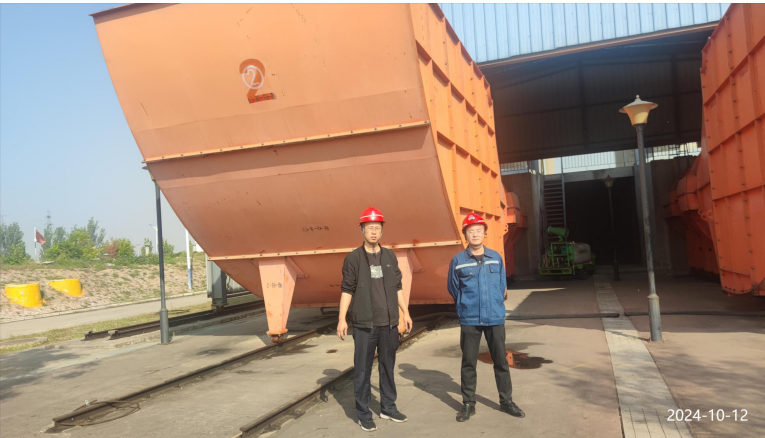
17	GX-B1340/23-9-24065	2024.11.22	西风井2#主要通风机系统合格。
