序号	报告编号	发布日期	结论	影像资料
69	GX-B1313/21-2-25017~25025	2025/3/14	本次共检电力变压器9台，9台所检项目合格。	 
70	GX-B1322/21-2-25022~25028	2025/3/14	本次共检电力电缆7条，7条所检项目合格。

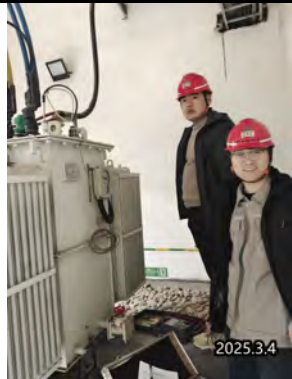
104	GX-B1313/21-2-25001~25004	2025. 3. 17	本次共检电力变压器4台，4台所检项目合格。 。

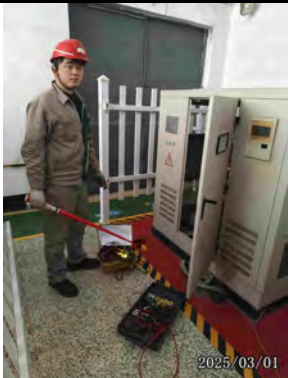
125	GX-B1313/21-2-25026~25028	2025/3/17	本次共检电力变压器3台，3台所检项目合格。 。

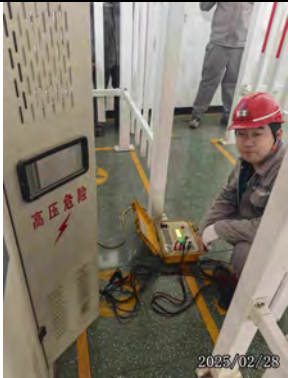
126	GX-B1313/21-2-25029~25031	2025/3/17	本次共检电力变压器3台，3台所检项目合格。 。

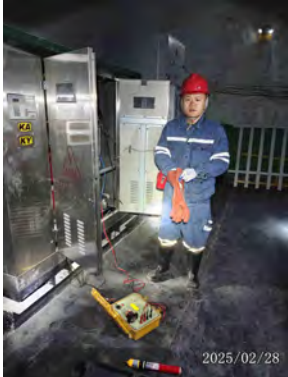
127	GX-B1313/21-2-25043~25047	2025/3/17	本次共检电力变压器5台，5台所检项目合格。 。
